Manhole Inspection Summary

Manhole # S71I__002MH

Insp Date: **12/16/08 7:52 AM**

Location Address: **Fait Ave.**

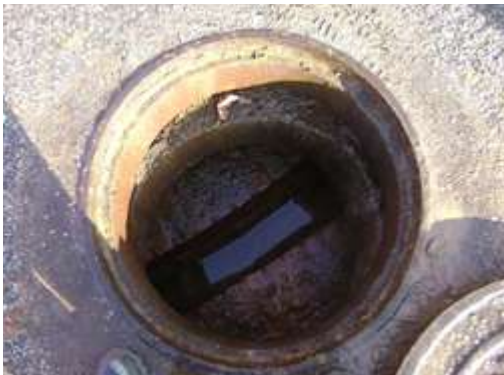
Defect 1

Frame Offset: **2** (in.) Condition: ☒ Sound ☐ Cracked ☐ Leaks

frame offset

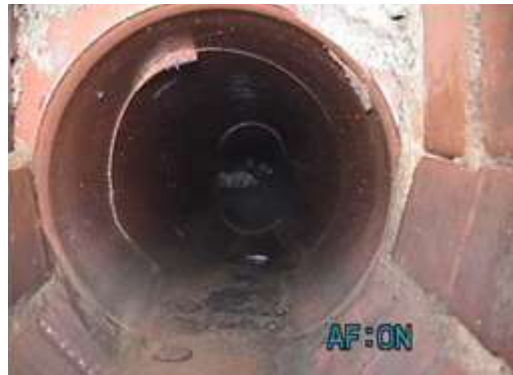
Defect 2

crack circumferential 7:00-6:00 incoming
6 o'clock

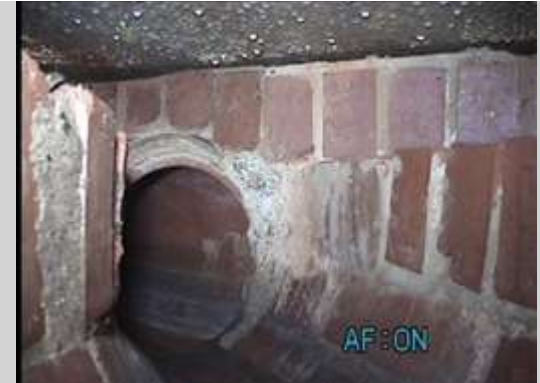
12 O'Clock Outflow

8 in. Circular Gravity Sewer
Pipe Out @ 12 O'Clock

Pipe Height: **8.4** (in.) Rod and Bar (Angled)
Pipe Material: **Clay** ☐ Pipe Lined
Invert Depth: **2.92** (ft.) Flow Characteristics: **None**
Deposits: ☒ None ☐ Mud ☐ ~~Gravy~~ ☐ Debris ☐ Grease
Silt Depth: (in.) Deposits Extent:
Infiltration: **None** Pipe Seal Cond: **Sound**

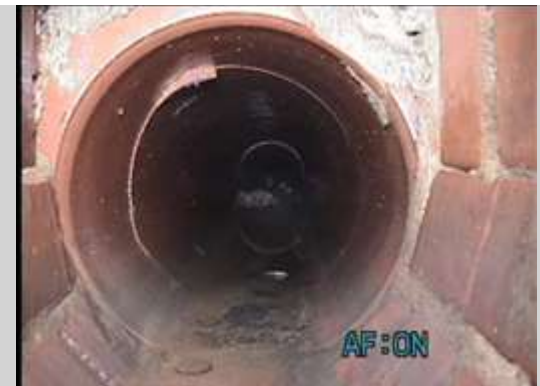
6 O'Clock Inflow

8 in. Circular Gravity Sewer
Pipe In @ 6 O'Clock

Pipe Height: **8.4** (in.) Rod and Bar (Angled)
Pipe Material: **Clay** ☐ Pipe Lined
Invert Depth: **2.88** (ft.) Flow Characteristics: **Slow**
Deposits: ☐ None ☐ Mud ☒ ~~Gravy~~ ☐ Debris ☐ Grease
Silt Depth: **0.25** (in.) Deposits Extent: **Light**
Infiltration: **None** Pipe Seal Cond: **Sound**
